# **Nine Elderly Fire Victims in Residential Hotel Miami, Florida (April 6, 1990)**

**Investigated by: Charles Jennings**

**This is Report 041 of the Major Fires Investigation Project conducted  
by TriData Corporation under contract EMW-90-C-3338 to the United  
States Fire Administration, Federal Emergency Management Agency.**

## **Nine Elderly Fire Victims in Residential Hotel Miami Beach, Florida**

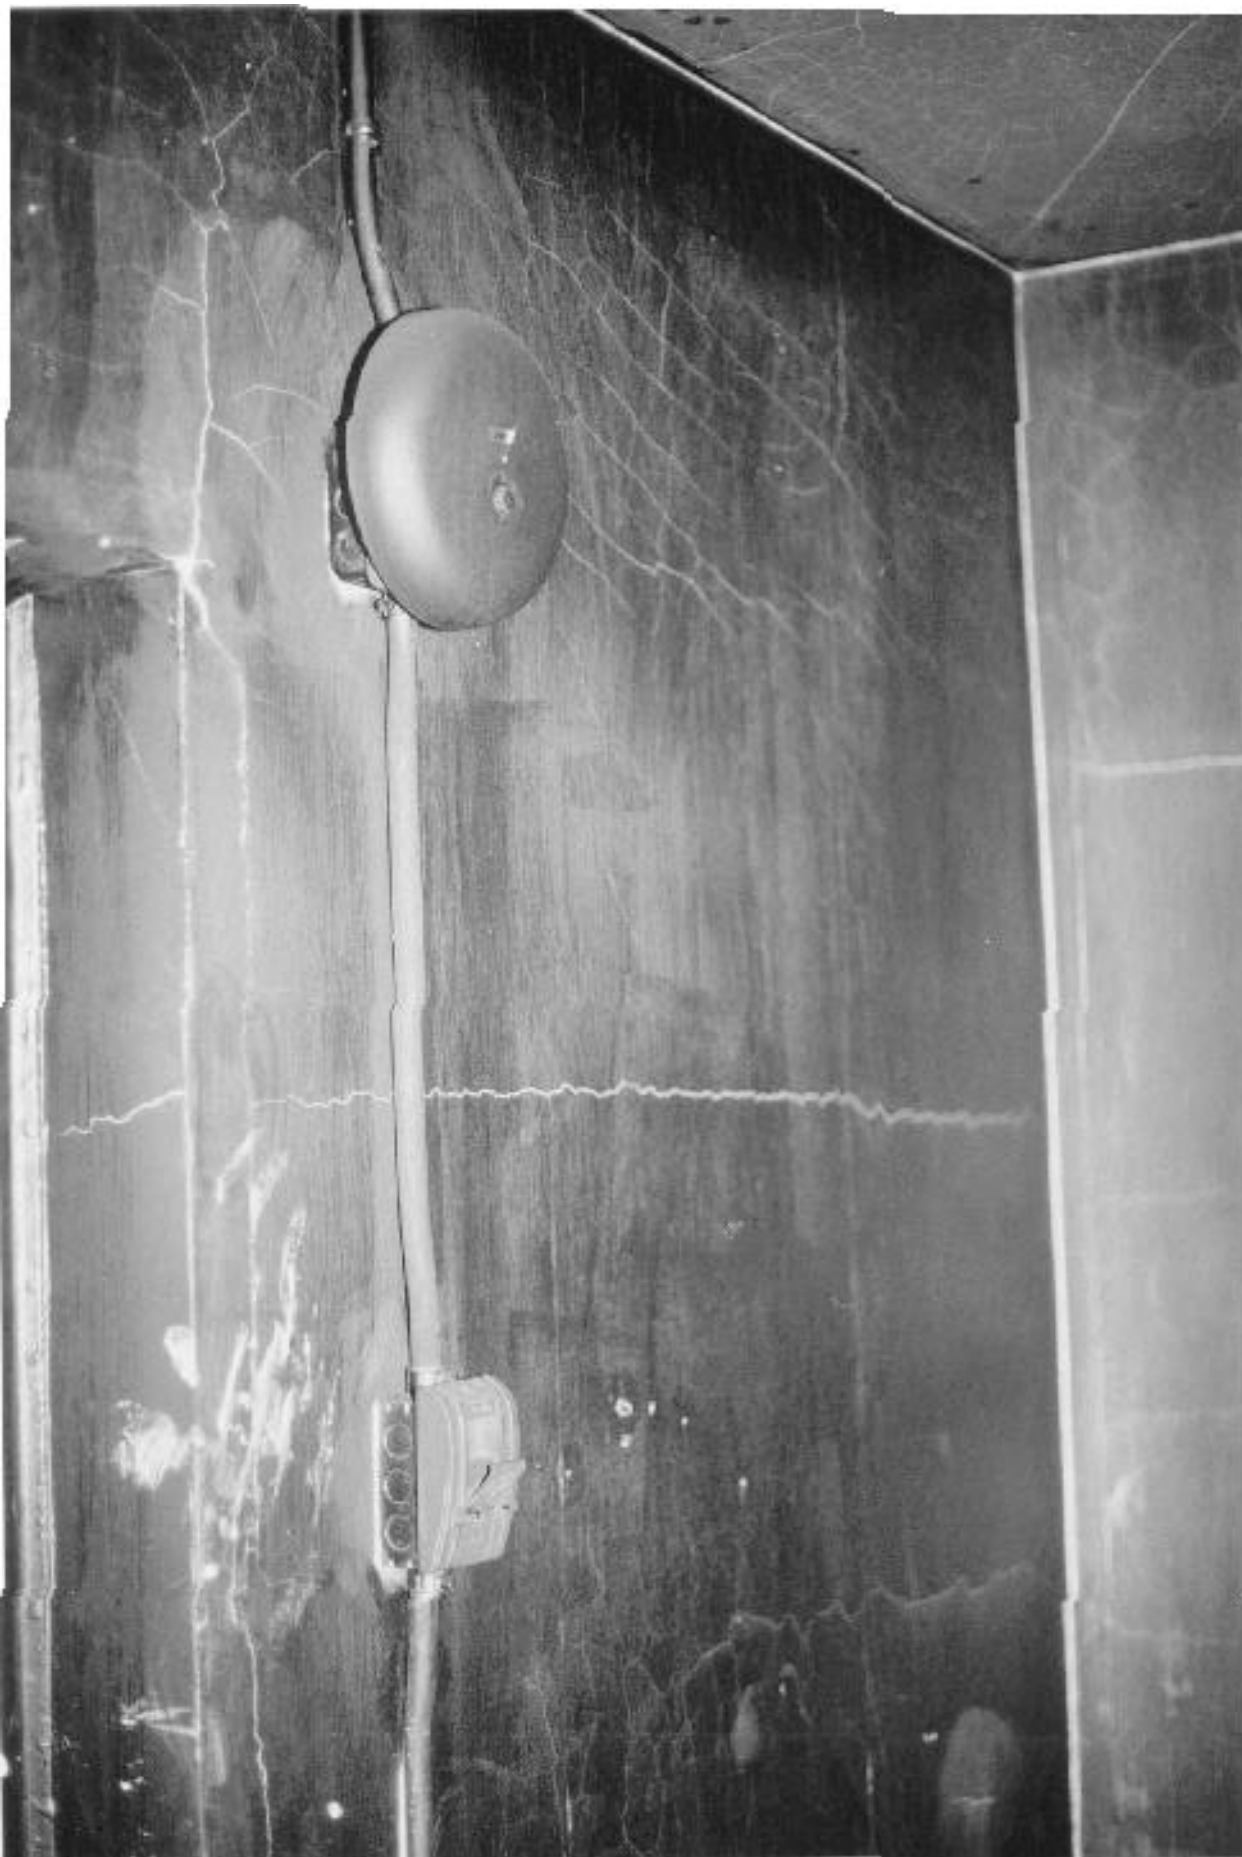
Manual tire alarm station and bell, third floor, at rear stair. Note extensive darkening soot.

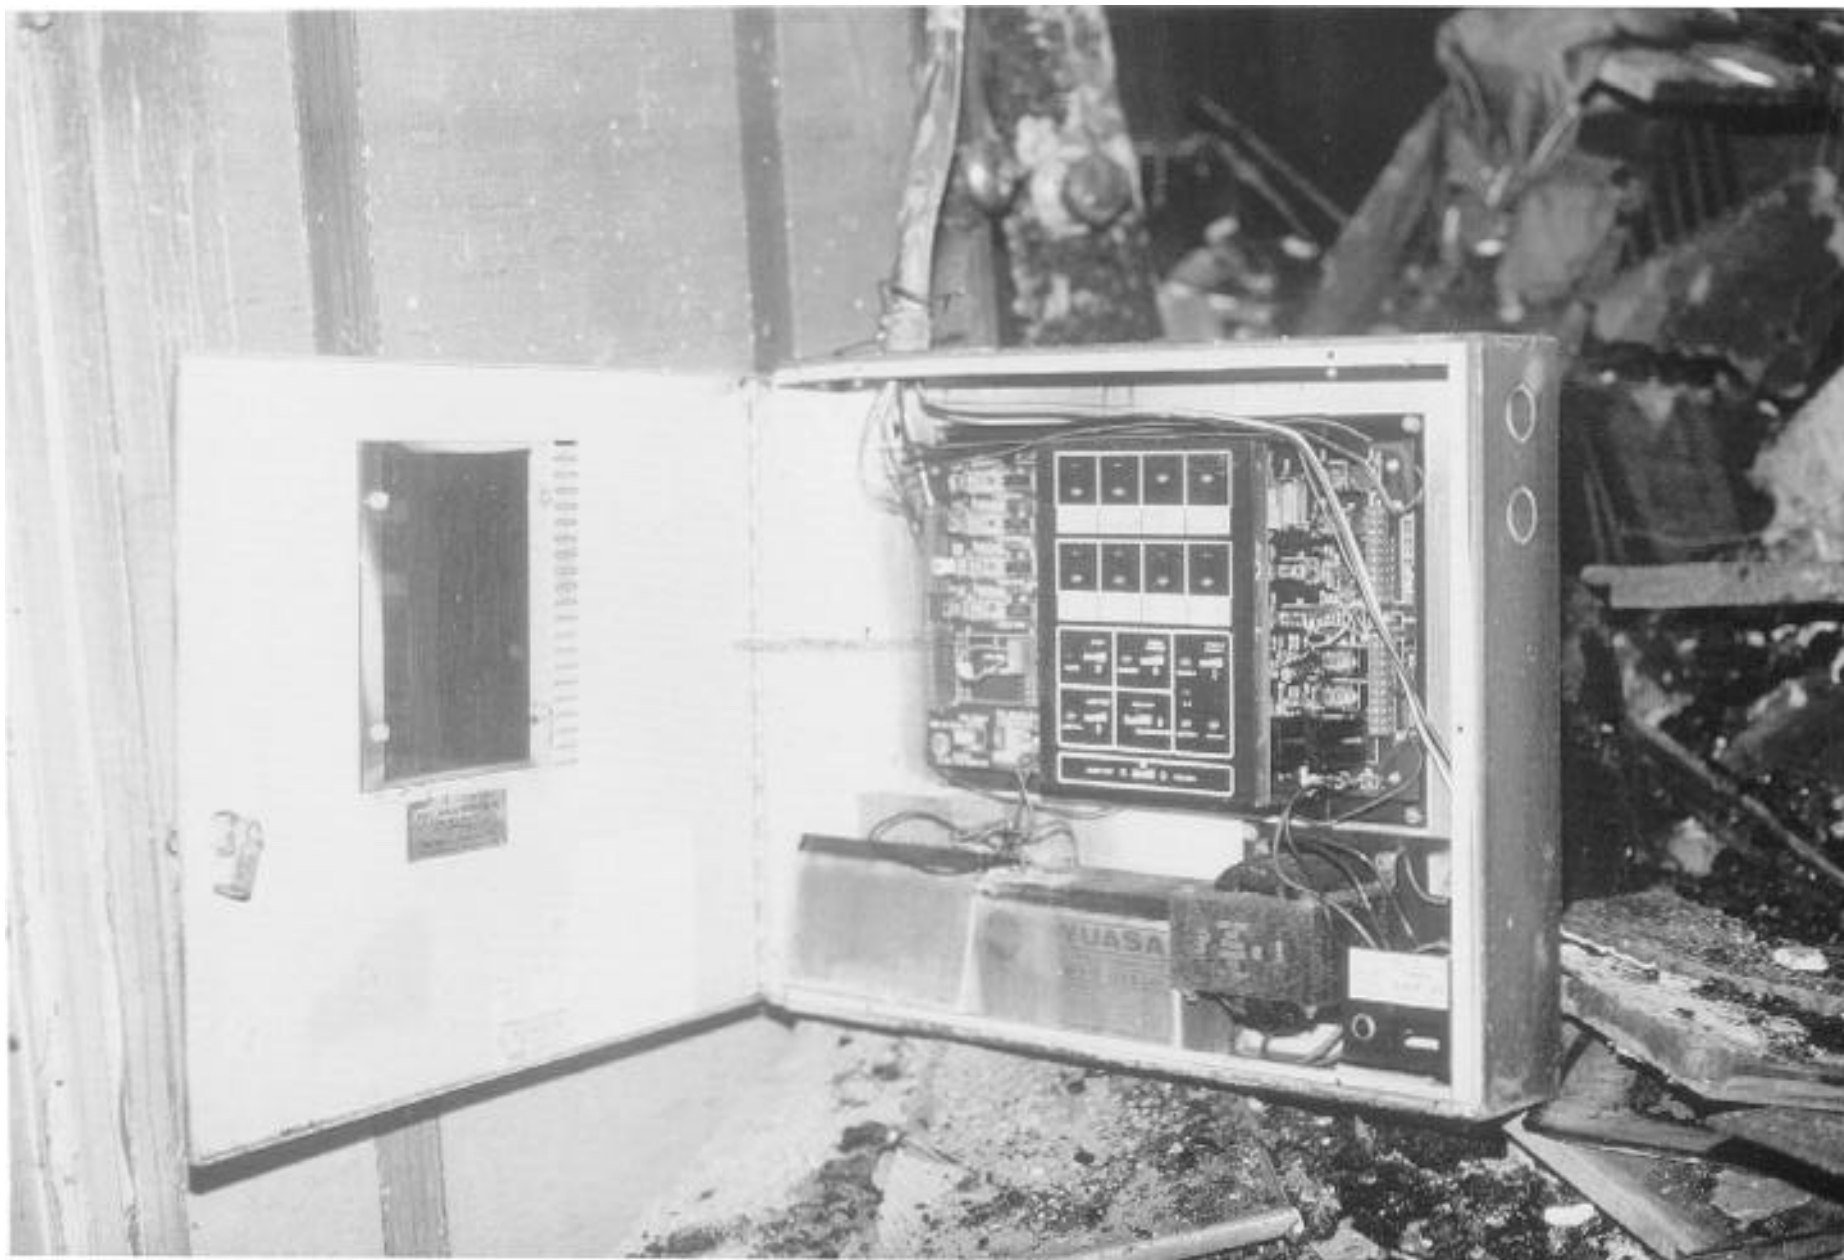
Single station hard-wired smoke detectors in guest rooms did activate. There were conflicting statements as to whether the building fire alarm was activated. The control wiring for the alarm ran through the concealed space where the fire originated, leading some to believe that by the time a manual station was pulled, the fire alarm wiring was destroyed. The fire alarm control panel was located in an office behind the front desk and remained basically intact throughout the fire. (See photograph, Appendix E.) The fact that corridor smoke detectors did not activate was consistent with the development of fire.

Remains of fire alarm control panel.
